MERRIMACK RIVER BASIN  
STERLING, MASSACHUSETTS

HYCREST FARM POND DAM  
MA 00673

PHASE I INSPECTION REPORT  
NATIONAL DAM INSPECTION PROGRAM

FEBRUARY 1979

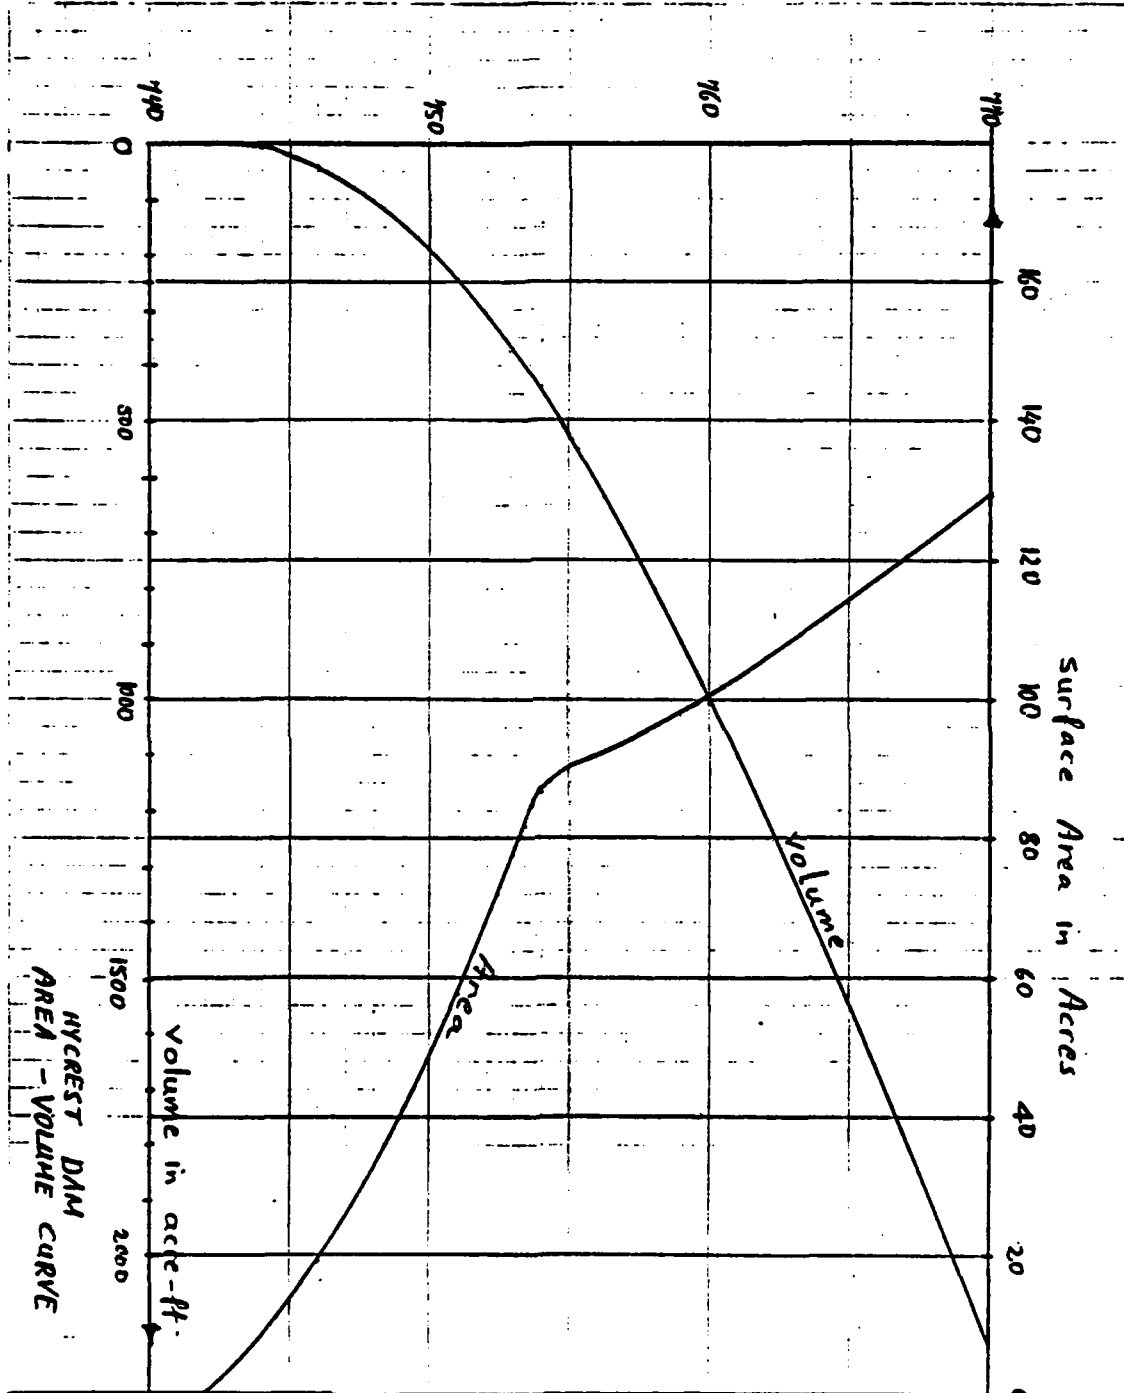
HYCREST DAM  
AREA - VOLUME CURVE

Conclusion: Dam would be overtopped by about 0.2-ft of water if the existing flash boards are all left in place.

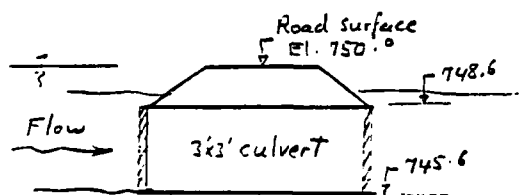
If  $Q > 75$  the road  
would be overtopped.

For test flood outflow of 150 cfs. the road  
would be overtopped by about 0.1-ft of water.
